## Venting Systems

## Materials

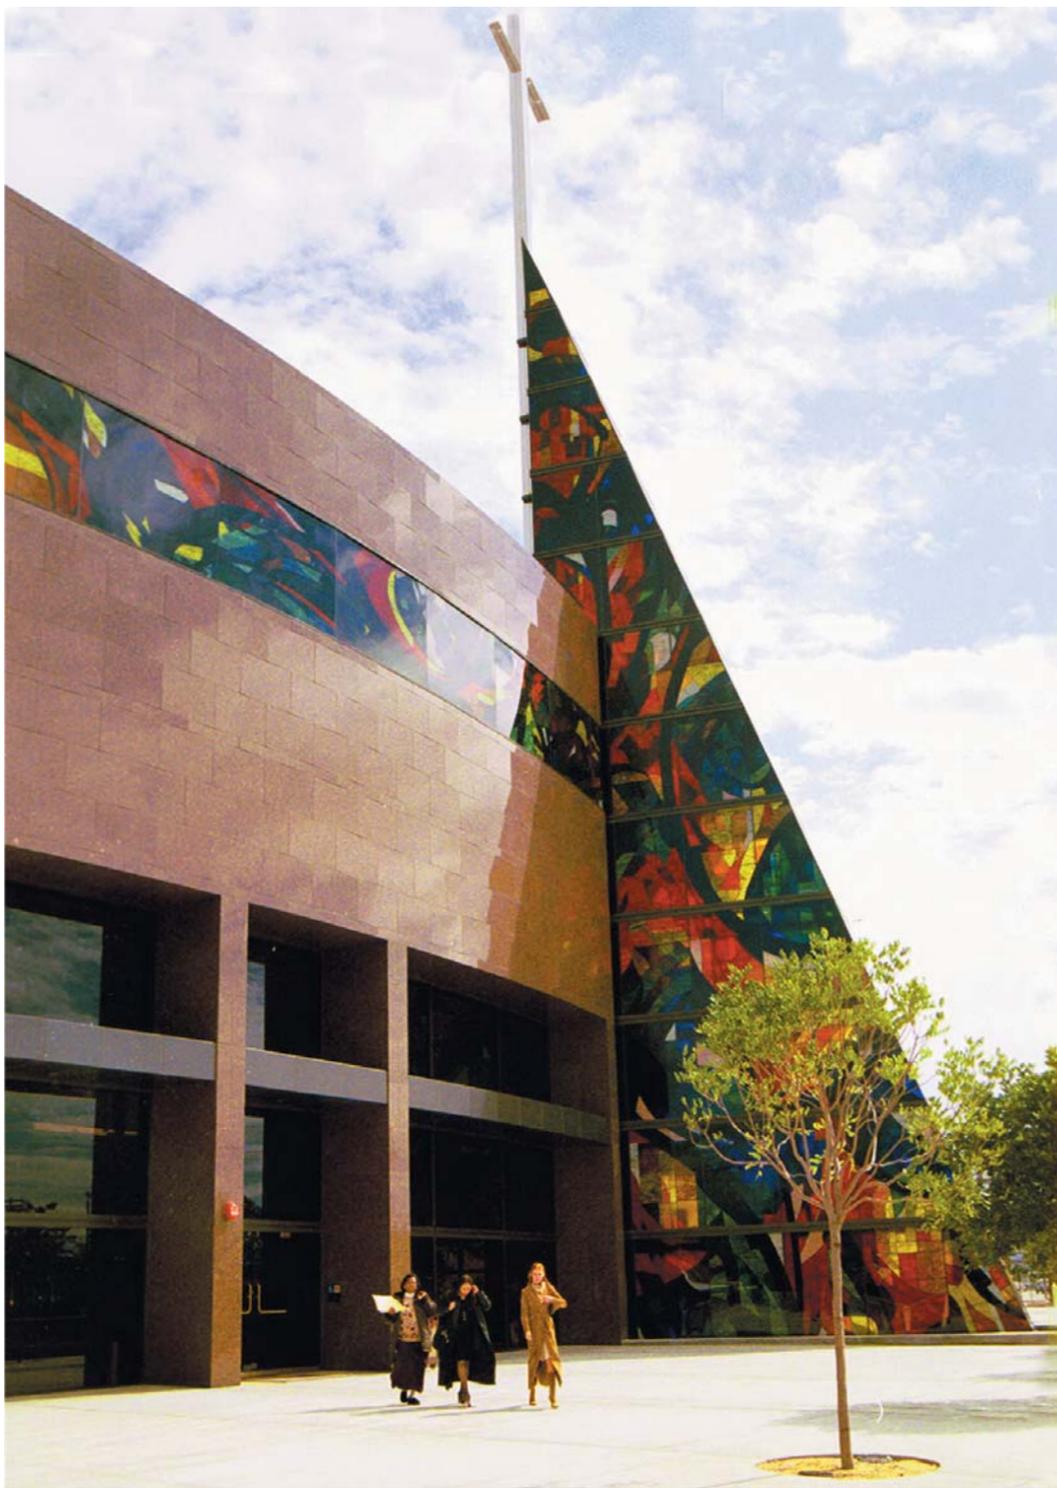
This stained-glass window in the West Los Angeles Cathedral in Los Angeles, CA, features ½-in. tempered laminated glass, a method that is approved for earthquake and hurricane codes.

Tempered laminated glass combines all of the clarity and beauty of float glass with the strength of tempered glass and the safety of laminated glass. The only drawback is its high cost.

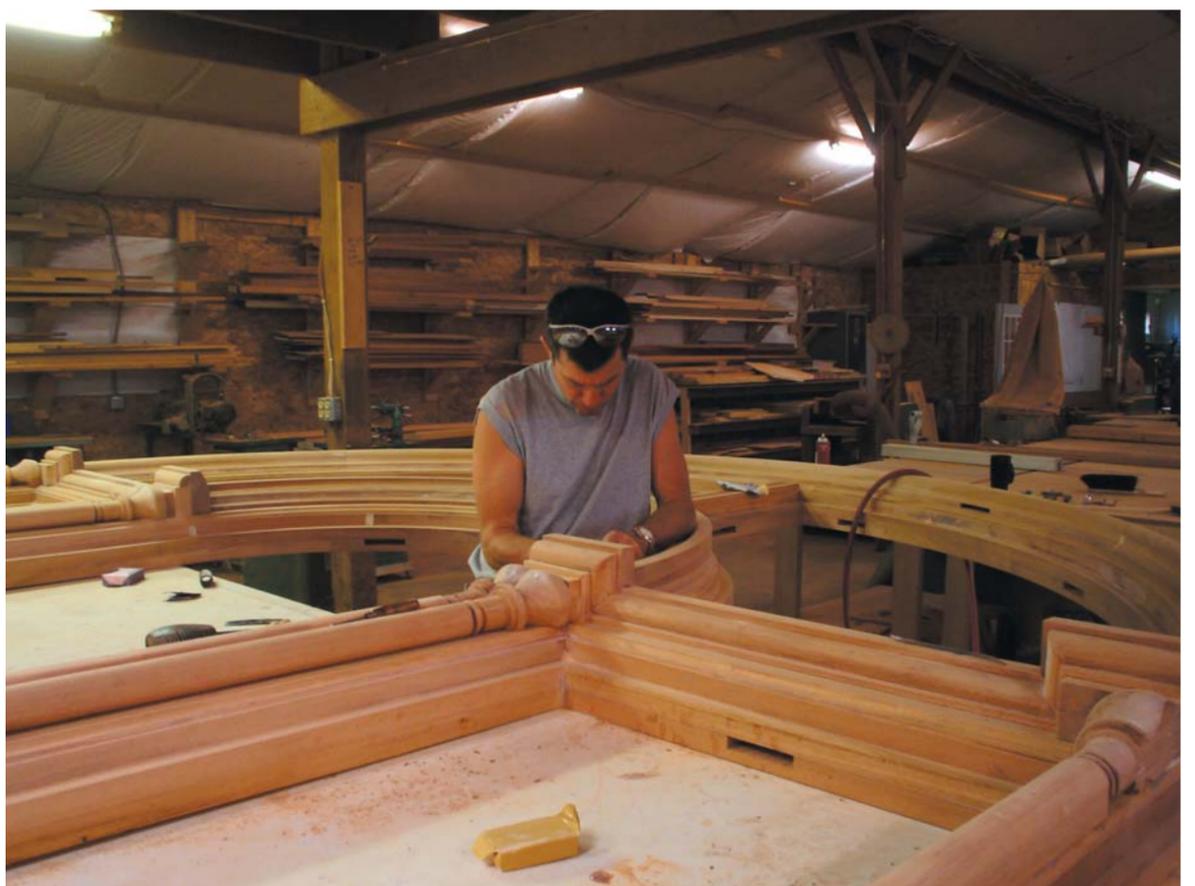
This craftsman at Bovard Studios is fabricating a ventilation system in a mahogany wood frame for the St. Cecilia Chapel, Dominican Sisters Motherhouse in Nashville, TN.

Precision Flow venting in our frames is designed to hold both stained glass and exterior glazing, whether in a single-glazed protective covering system or insulated-glass exterior glazing system. It is designed to the guidelines of 1 sq.in. of ventilation to 16 sq.ft. of stained glass in the bottom and top of the unit, with a gravity flow system. Hot air rises, causing the heat buildup and condensation to escape at the top of the unit.
